# Manhole Inspection Summary

Manhole # S15AA1006MH

Insp Date: **3/15/07 11:19 AM**

**Location** Address: **3624 COTTAGE AVE**

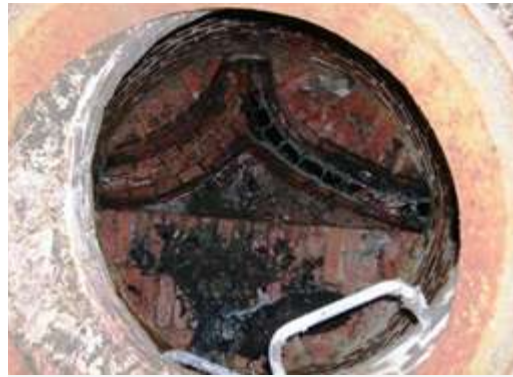
Top View

☒ **Evidence Of Surcharge** Depth: **1** (ft.) ☐ Active Surcharge Present

Evidence of surcharge - Bench debris.

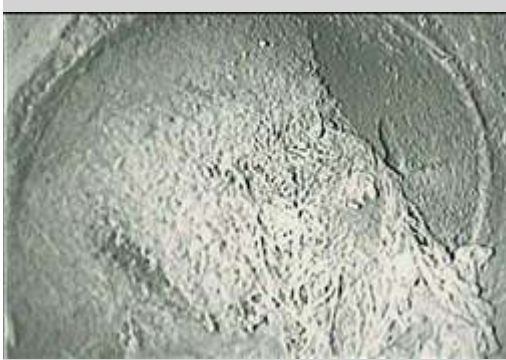
Inside the I9

Comments **The I9 pipe has heavy root intrusion inside of the Drop ext. pipe.**

Heavy root intrusion.

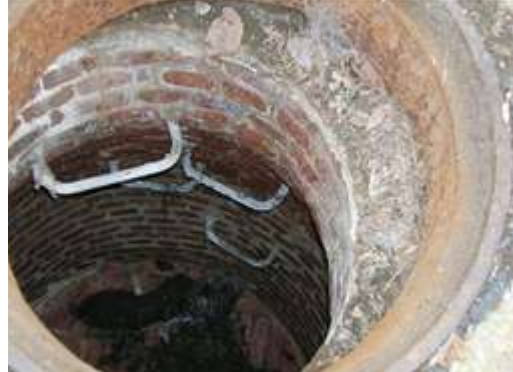
Defect

Offset: **5** (in.)

Condition: ☐ Sound ☐ Cracked ☐ Root Intrusion ☐ Loose Brick ☒ **Deteriorated**

Infiltration: ☐ None ☒ **Joint** ☐ Cracks ☐ Mortar ☐ Roots ☐ Wall

Frame offset. Adjustment deterioration and infiltration. Barrel infiltration.

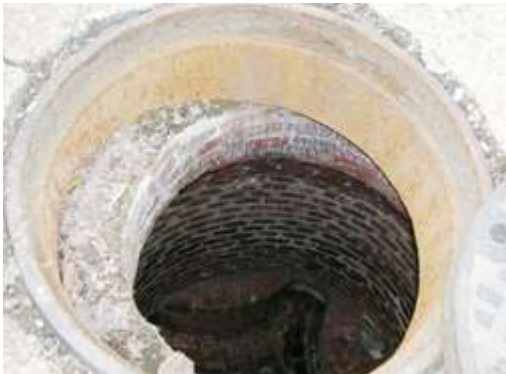
Defect

Frame offset. Adjustment and Barrel infiltration - other side.

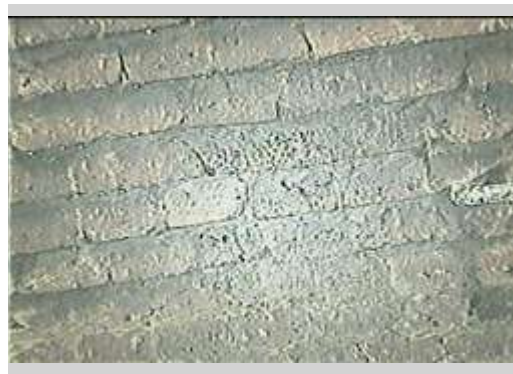
Defect

Condition: ☐ Sound ☐ Cracked ☐ Root Intrusion ☐ Loose Brick ☒ **Deteriorated**

Infiltration: ☐ None ☐ Joint ☐ Cracks ☐ Mortar ☐ Roots ☒ **Wall**

Barrel infiltration.

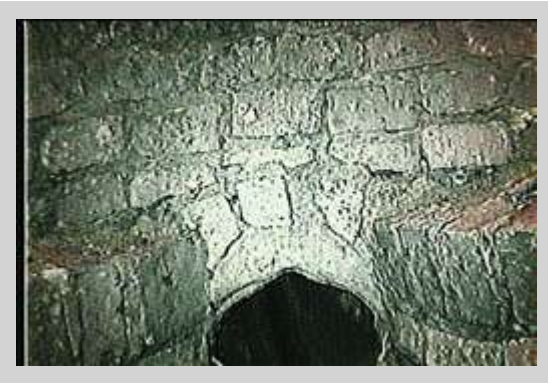
### 8 in. Circular Gravity Sewer Pipe Out @ 12 O'Clock

Barrel deterioration and infiltration.

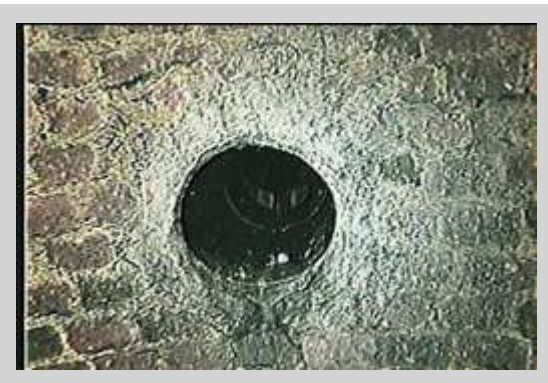
### 8 in. Circular Gravity Sewer Pipe In @ 3 O'Clock

Deposits: ☐ None ☐ Mud ☐ Sludge ☒ Debris ☒ Grease

Silt Depth: **0** (in.) Deposits Extent: **Light**

Infiltration: **None** Pipe Seal Cond: **Cracked**

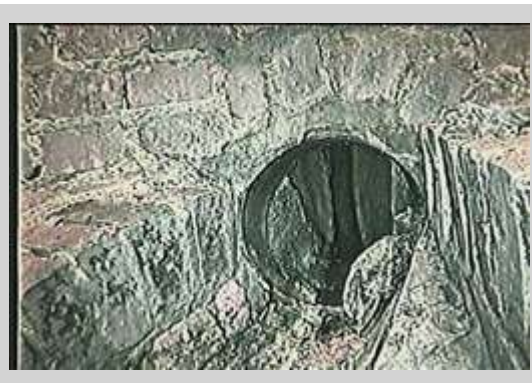
### Drop In @ 3 O'Clock

Condition: ☐ Sound ☐ Cracked ☐ Root Intrusion ☒ **Deteriorated** ☐ Leaks ☐ Debris

Barrel deterioration and infiltration. Channel deterioration.

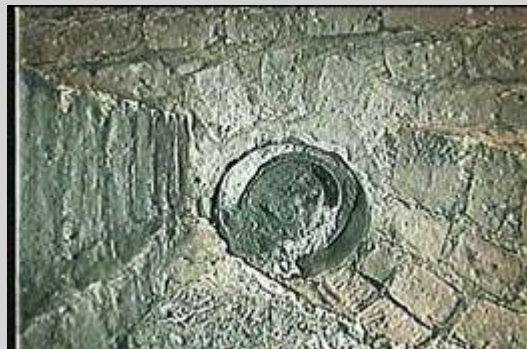
Pipe In @ 9 O'Clock

Deposits: ☐ None ☐ Mud ☐ Sludge ☒ **Debris** ☒ **Grease**

Infiltration: **Evidence**

Connects To: **Stub connection / abandoned**
